**ENVIRONMENTAL CONDITION OF  
PROPERTY REPORT**

**BOSSIER CITY  
U.S. ARMY RESERVE CENTER (LA007)  
300 MILLER ROAD  
BOSSIER CITY, LOUISIANA 71112**

**February 8, 2007**

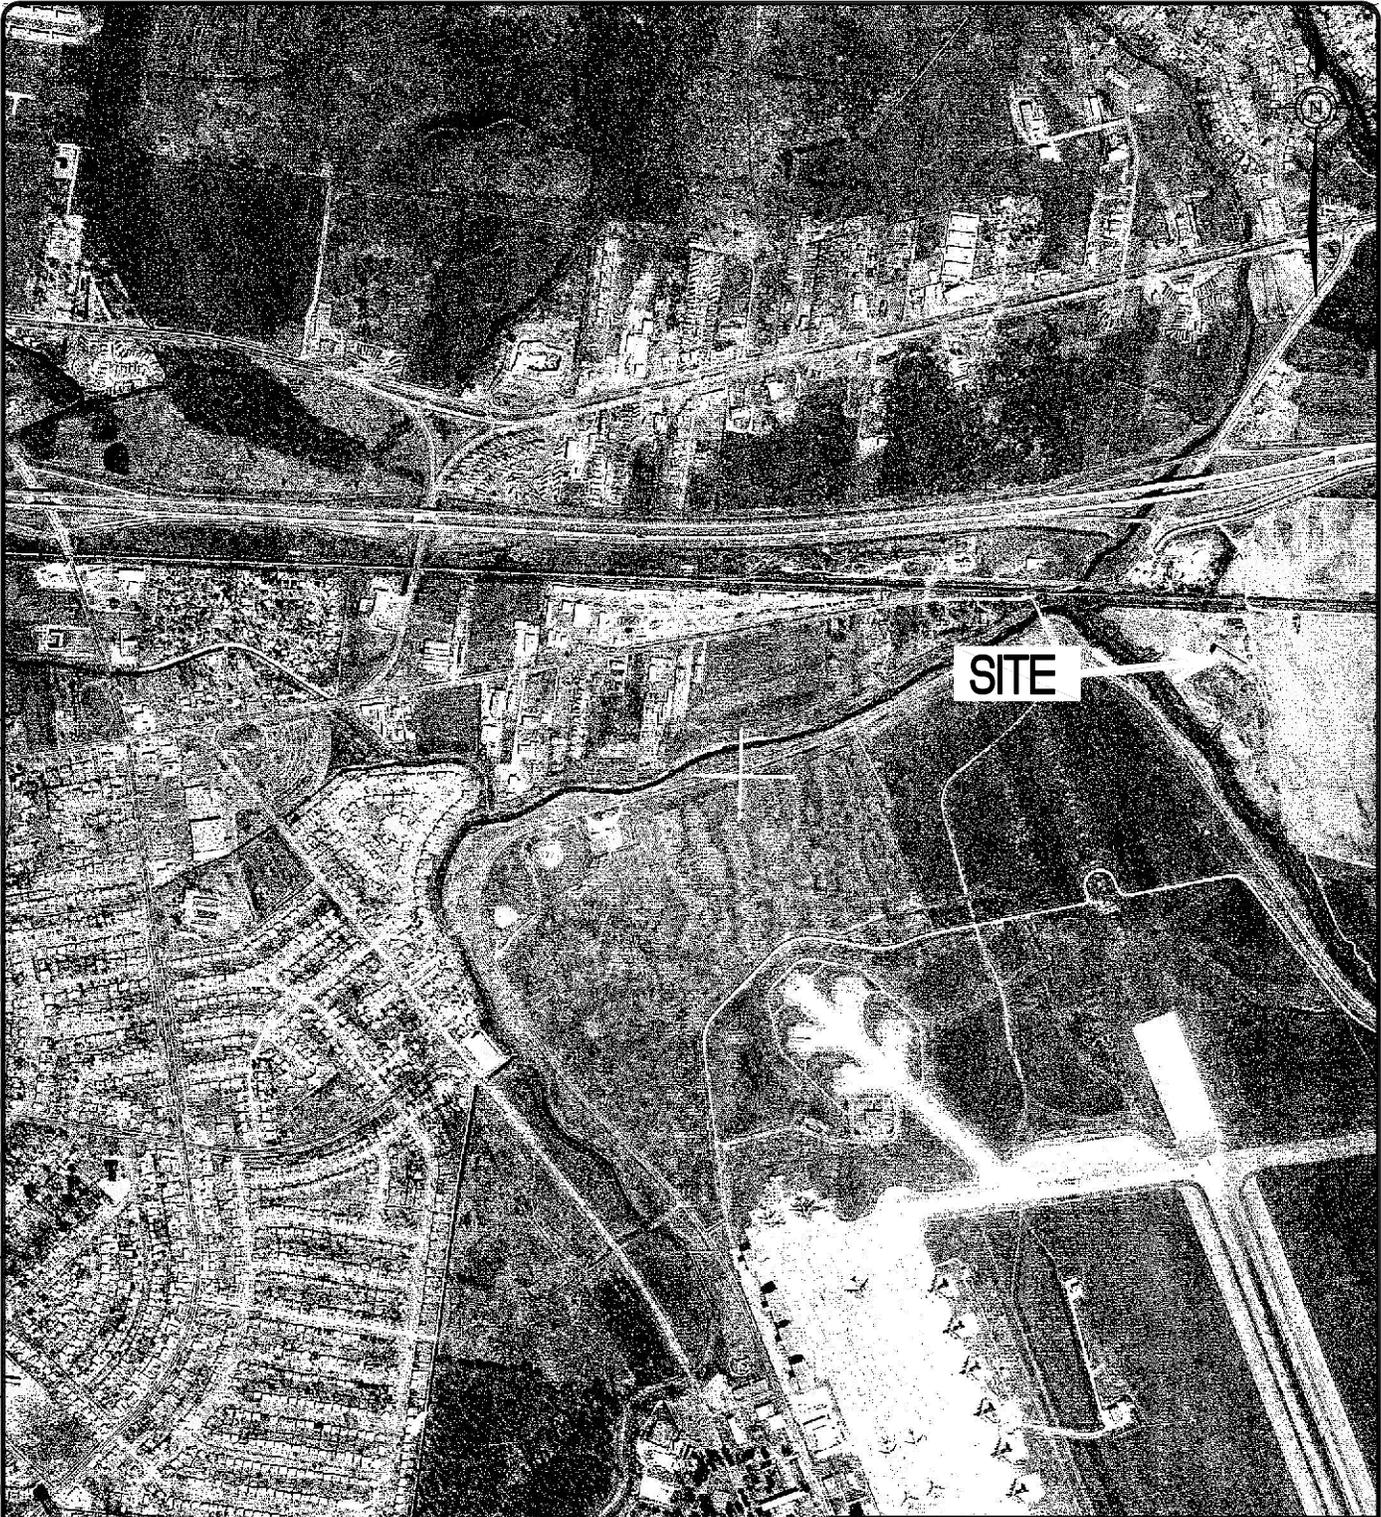
FIGURE 12  
1972 AERIAL PHOTOGRAPH  
ENVIRONMENTAL CONDITION OF PROPERTY  
BOSSIER CITY USAR CENTER  
BOSSIER CITY, LOUISIANA

- **1972 and 1974 (Figures 12 and 13).** The 1972 and 1974 aerial photographs show the Site property to be undeveloped and vacant, except for what appears to be a trailer or Quonset hut near the eastern boundary of the Site. No records were found regarding that structure.

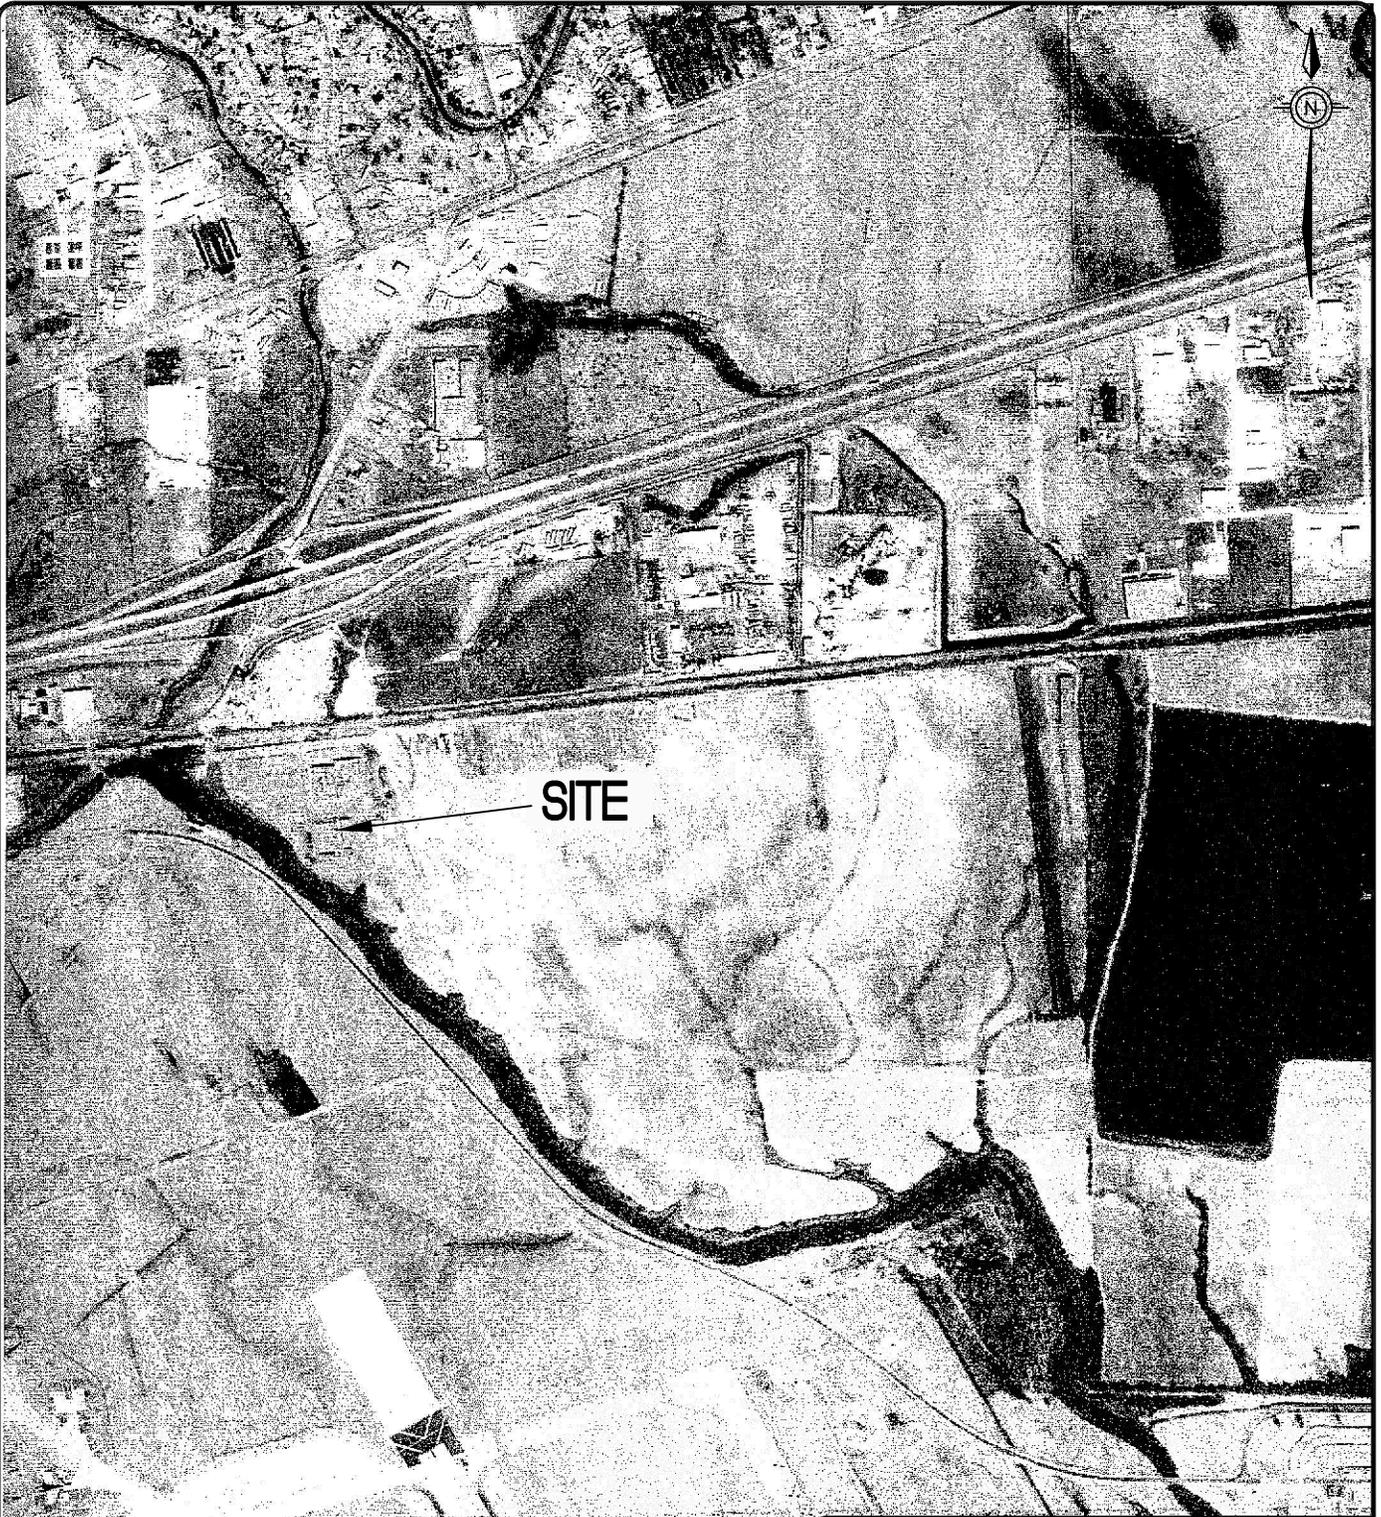
FIGURE 14  
1982 AERIAL PHOTOGRAPH  
ENVIRONMENTAL CONDITION OF PROPERTY  
BOSSIER CITY USAR CENTER  
BOSSIER CITY, LOUISIANA

- **1982 (Figure 14).** The 1982 aerial photograph shows the Training Building, OMS, and MEP area. The POV parking lot and REC shelter had not been developed. The trailer/Quonset hut structure observed in the 1972 aerial photograph had been removed.

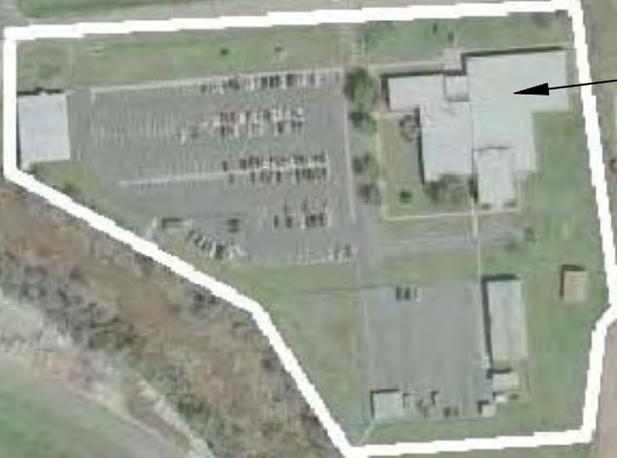
FIGURE 15  
2002 AERIAL PHOTOGRAPH  
ENVIRONMENTAL CONDITION OF PROPERTY  
BOSSIER CITY USAR CENTER  
BOSSIER CITY, LOUISIANA

- **2002 (Figure 15).** The 2002 aerial photograph shows the addition of the POV parking lot, the VWR, the REC shelter, and the flammable materials storage locker at the USAR Center. The USACE building on the northwest side of the Site is also present.

Figure 15 in Appendix A provides a 2002 aerial view of the Site and adjacent properties. To the north is Miller Road. Beyond Miller Road are the Illinois Central Gulf railroad tracks. Beyond the railroad tracks is I-20. Cooper Bayou is a water body that parallels the property boundary to the west and south. The perimeter of Barksdale Air Force Base is west and south of Cooper Bayou. The USACE Ft. Worth District — Eastern Area Office is on the northwest side of the Site. Agricultural fields are east of the site. Table 2 provides a list of adjacent properties with their directional location in regards to the Site. The zoning of the adjacent parcels is also listed in Table 2.

According to information obtained from the City of Bossier City, the Site and surrounding area to the north, west, and south are zoned A-1, Air Base Buffer, while the surrounding area to the east is zoned R-A, Residential/Agricultural. Figure 15 in Appendix A provides a 2002 aerial photograph of the USAR Center and surrounding properties, and depicts current land use. As shown in that figure, Miller Road is north of the Site. The USACE Ft. Worth District — Eastern Area Office is on the northwest side of the Site. Cooper Bayou is a water body that parallels the property boundary to the west and south. The perimeter of Barksdale Air Force Base is west and south of Cooper Bayou. Agricultural fields are east of the site.

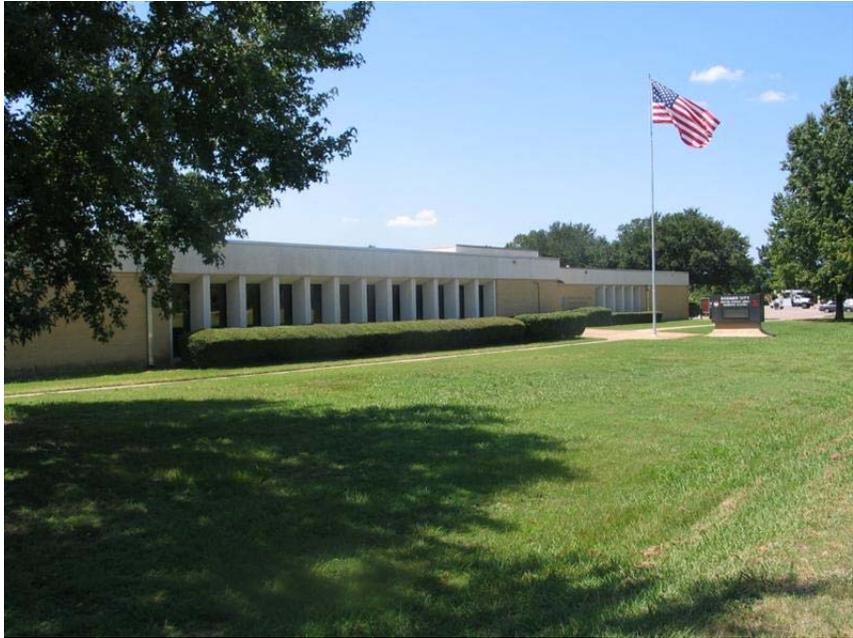
Photo 2: Looking southwest toward the north side of the Training Building.

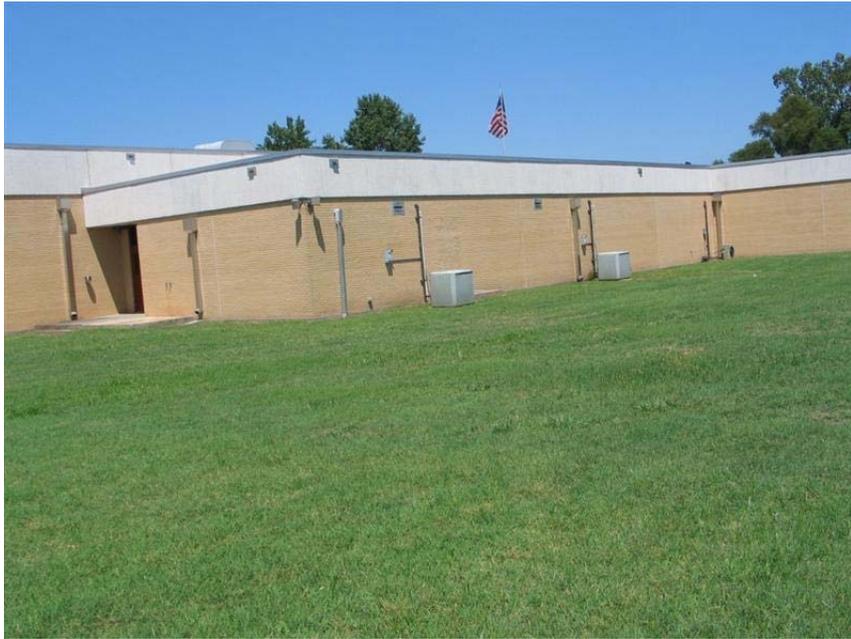
**Photo 3:** Looking northwest toward the Training Building.

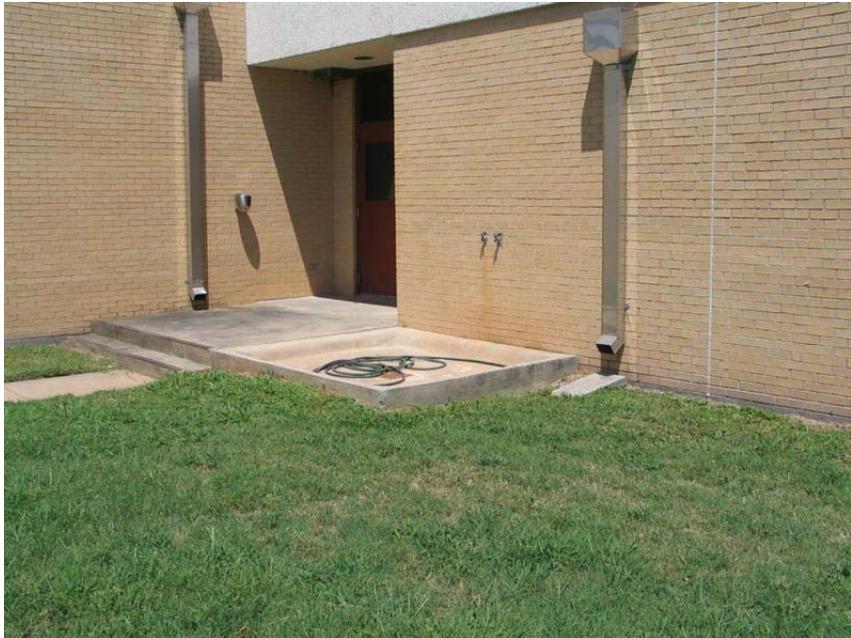
**Photo 4:** Close-up of wash pad on the east side of the Training Building. A floor drain on the pad is connected to the sanitary sewer via a grease trap.

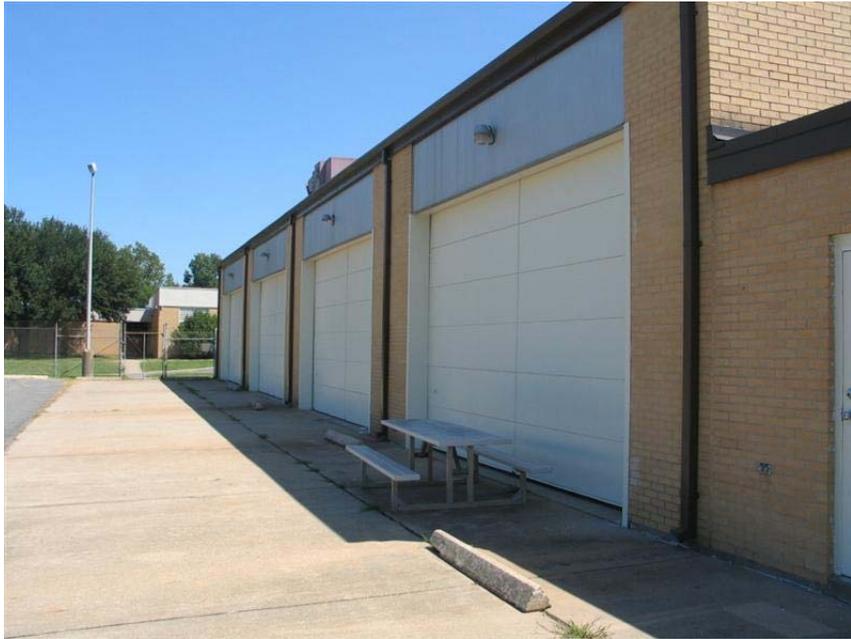
**Photo 5:** Looking north along the west wall of the OMS. The Training building is visible in the background and the MEP area is to the left.

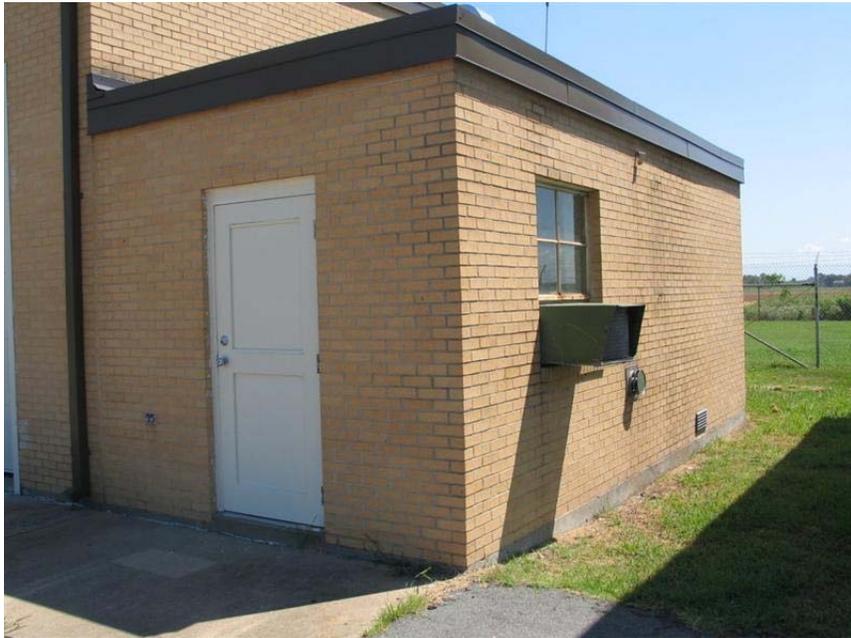
**Photo 6:** Looking northeast toward the offices at the southern end of the OMS. Note the air conditioning unit in the window.

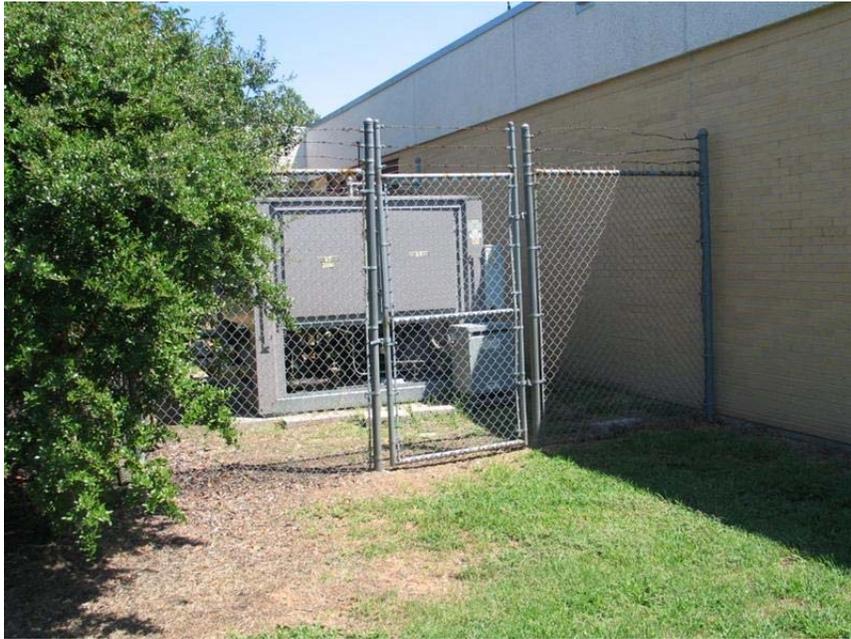
**Photo 7:** Looking north toward a HVAC unit on the west side of the Training Building.

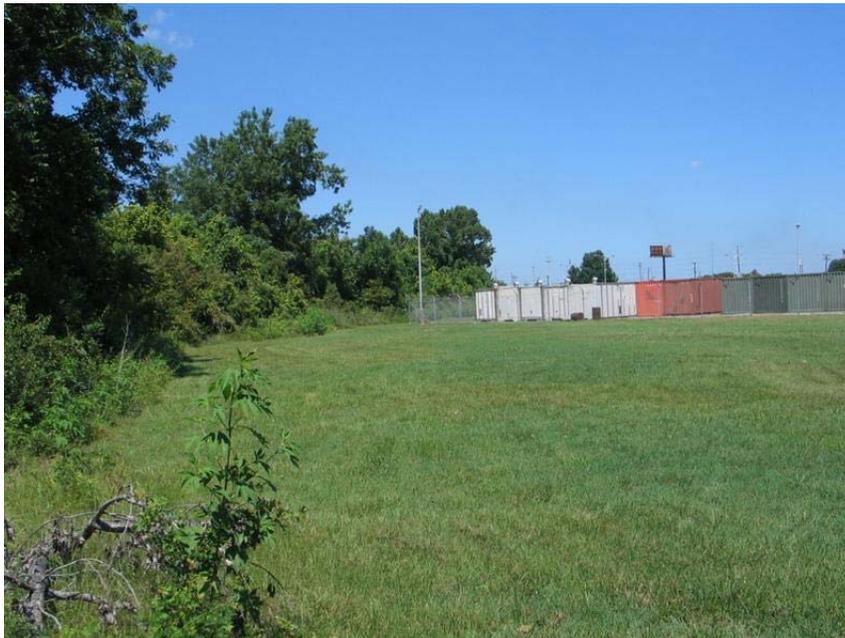
**Photo 10:** Looking northwest toward the southwest corner of the MEP area. Shipping containers in the parking area are used for storage and the tree-line to the left denotes the east bank of Cooper Bayou.

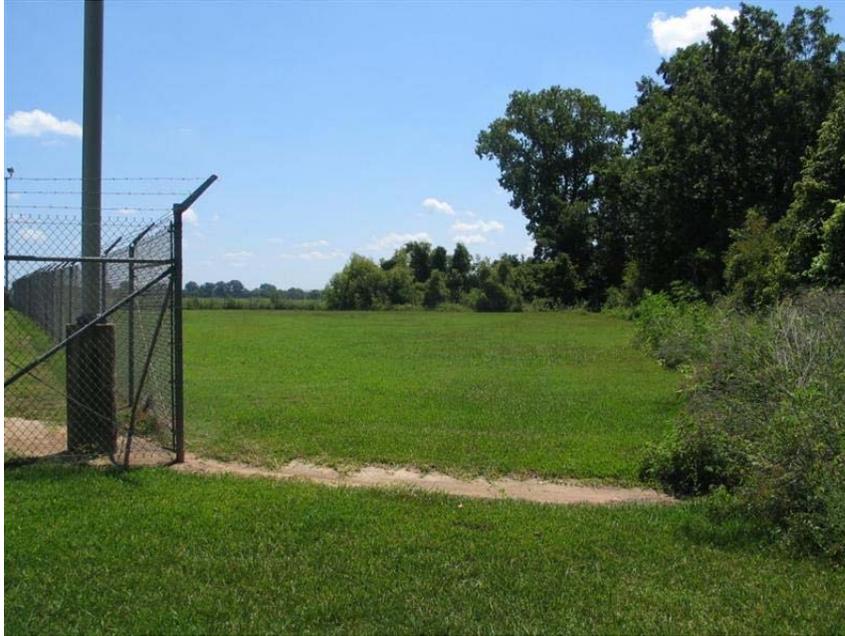
**Photo 11:** Looking south from the southwest corner of the MEP area. Cooper Bayou is to the right and a concrete storm water ditch is in the foreground.

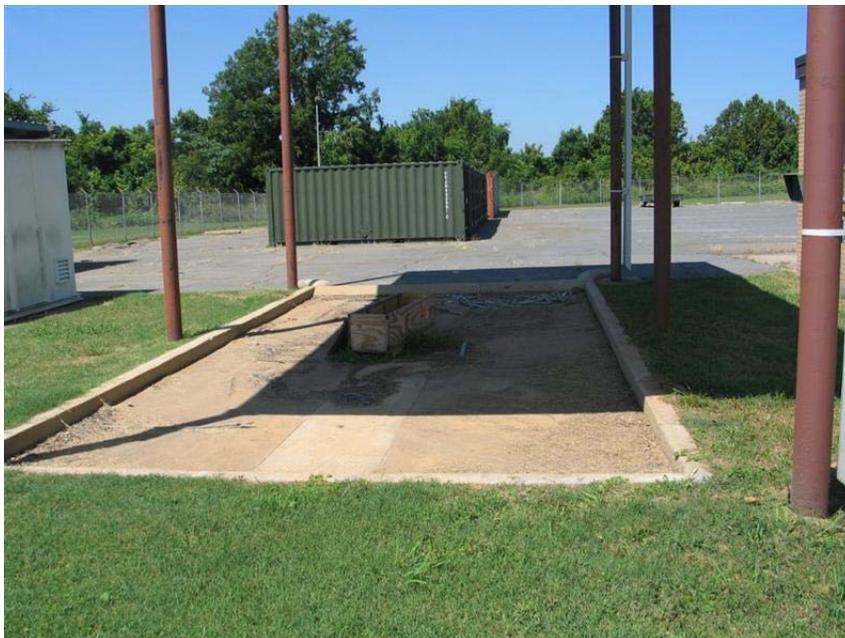
**Photo 12:** Looking west at the vehicle wash rack. The center of the washing pad has a slotted floor drain that is connected to an OWS. The OWS (not shown in this view) is on the east side of the wash rack. Shipping containers and the MEP area are visible in the background. Also, the tree-line denotes the bank of Cooper Bayou.

The VWR has a concrete foundation with a 6-inch containment curb on the north, south, and east sides, and a ramp on the west side. The floor of the foundation slopes toward a slotted floor drain that is connected to an underground 575-gallon OWS. The OWS is located on the east side of the VWR. The OWS is of steel construction, covered with fiberglass reinforced polyester resin, and is connected to the sanitary sewer. No permit is required for this OWS.

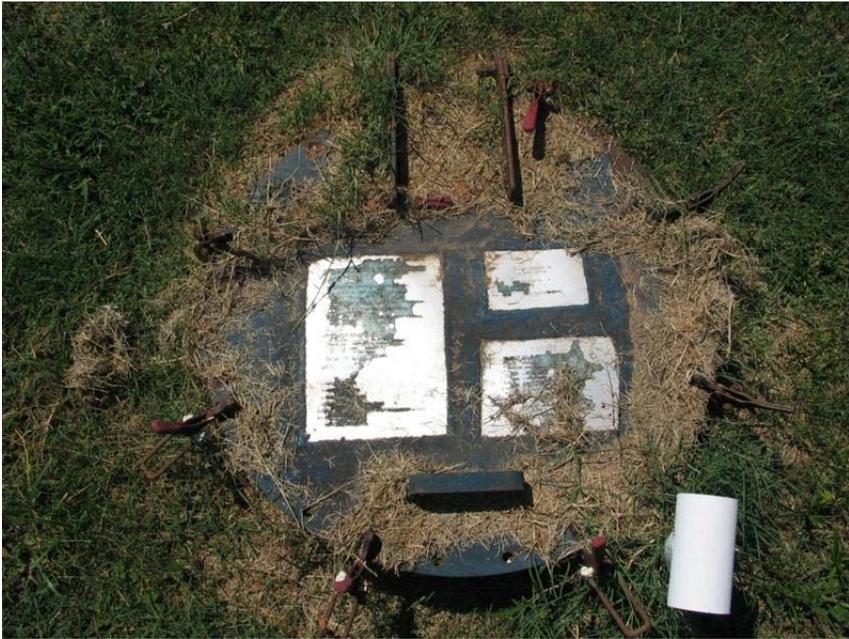
**Photo 13:** Close-up of the OWS that serves the vehicle wash rack.

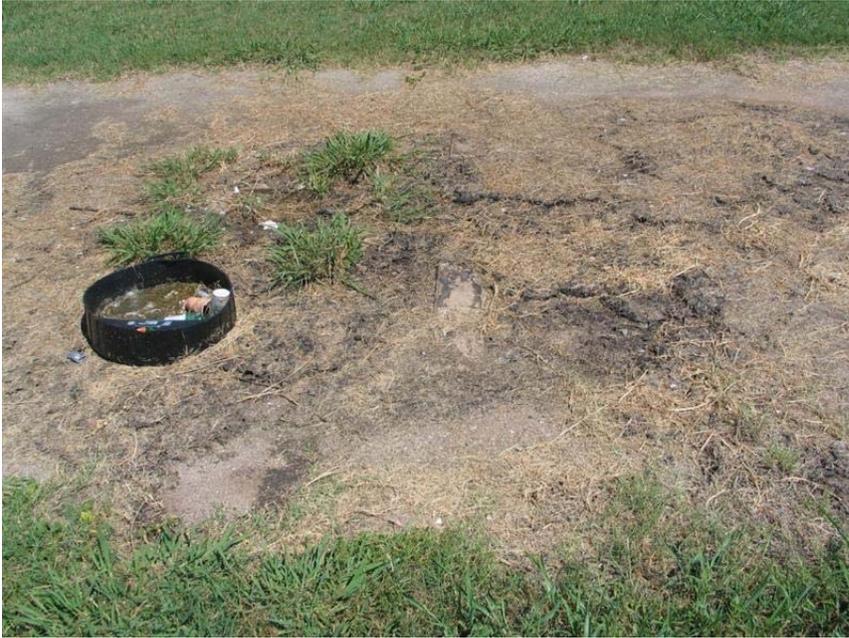
**Photo 14:** Close-up of former wash pad that is no longer in use. According to USAR personnel, the pad appears to be the remnant of a previously removed grease rack.

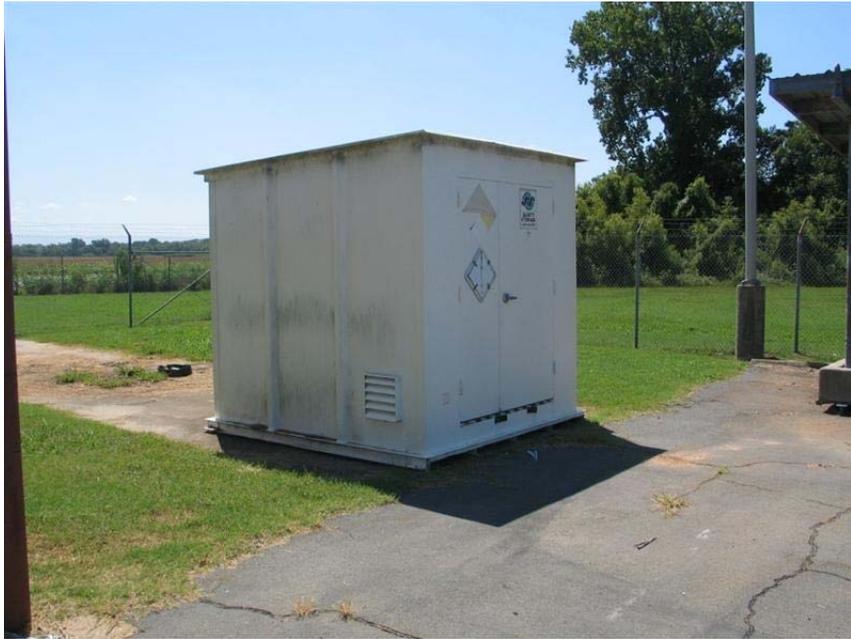
**Photo 15:** Looking southeast at a flammable materials storage locker, located at the southeast end of the MEP area.

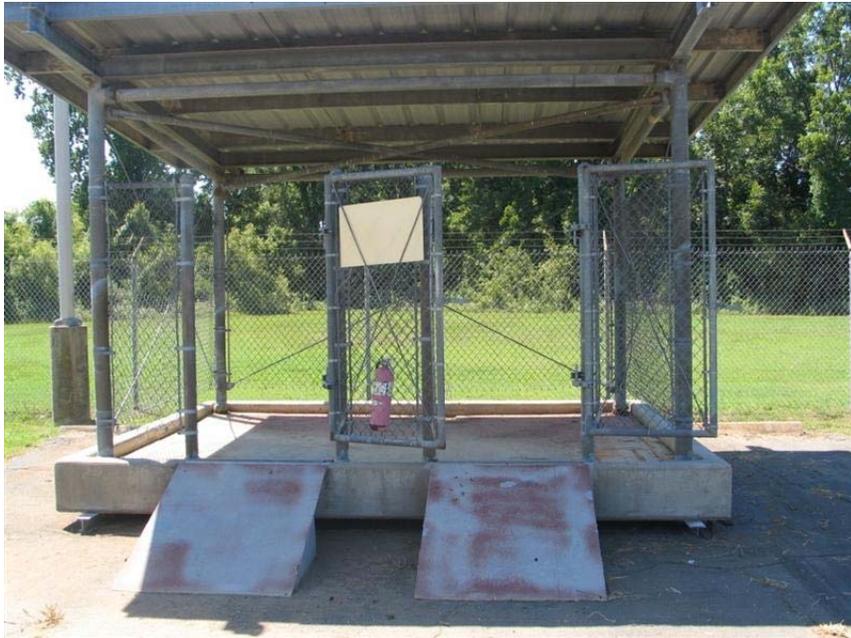
**Photo 16:** Looking south at the gated storage area on the southeast side of the MEP area.

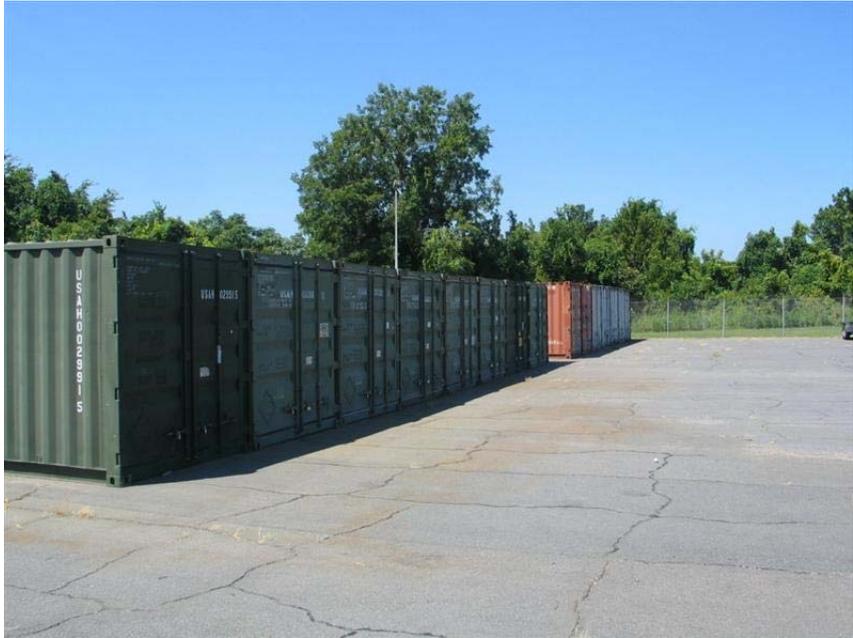
**Photo 17:** Looking southwest along the southern end of the MEP area showing a row of shipping containers.

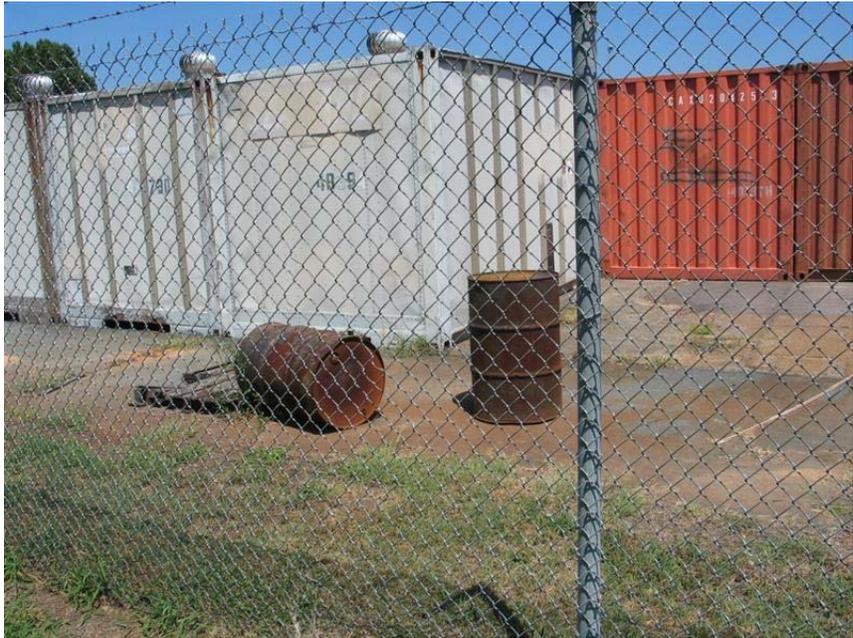
**Photo 18:** Looking northeast at shipping containers located on the south side of the MEP area. Empty, unused drums are visible next to the shipping containers.

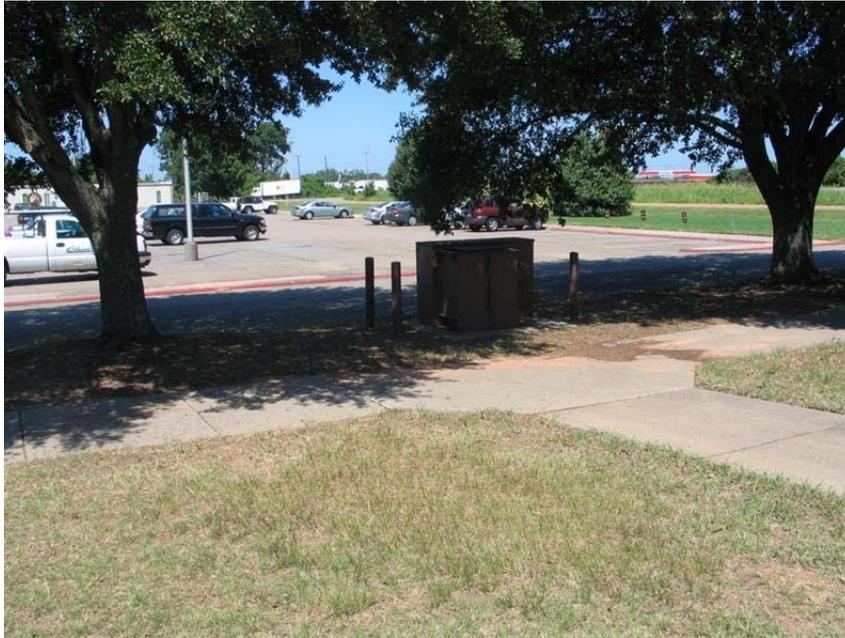
**Photo 21:** Looking west toward a pad-mounted transformer on the west side of the Training Building. The POV parking lot is in the background.

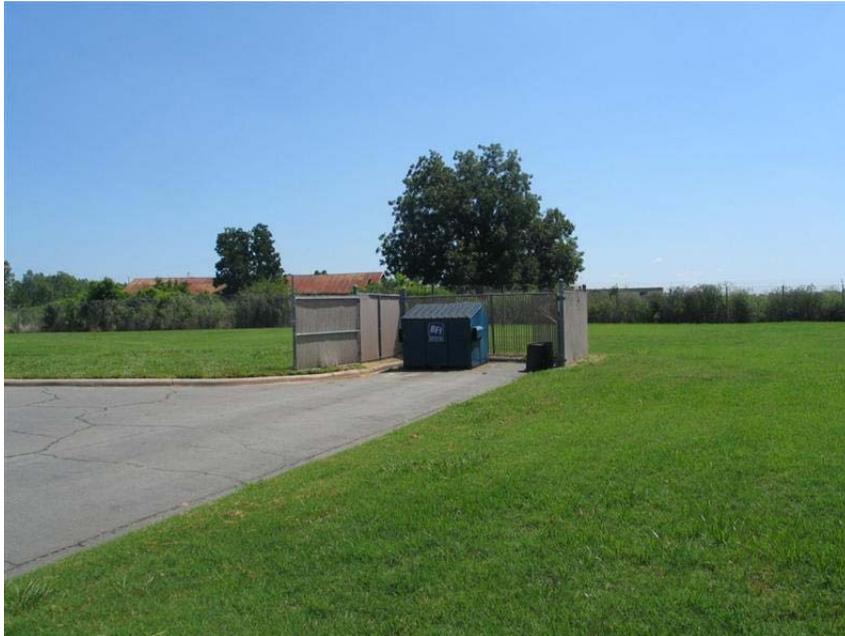
**Photo 22:** Looking east toward the dumpster storage area. Solid waste is collected by BFI, Inc.

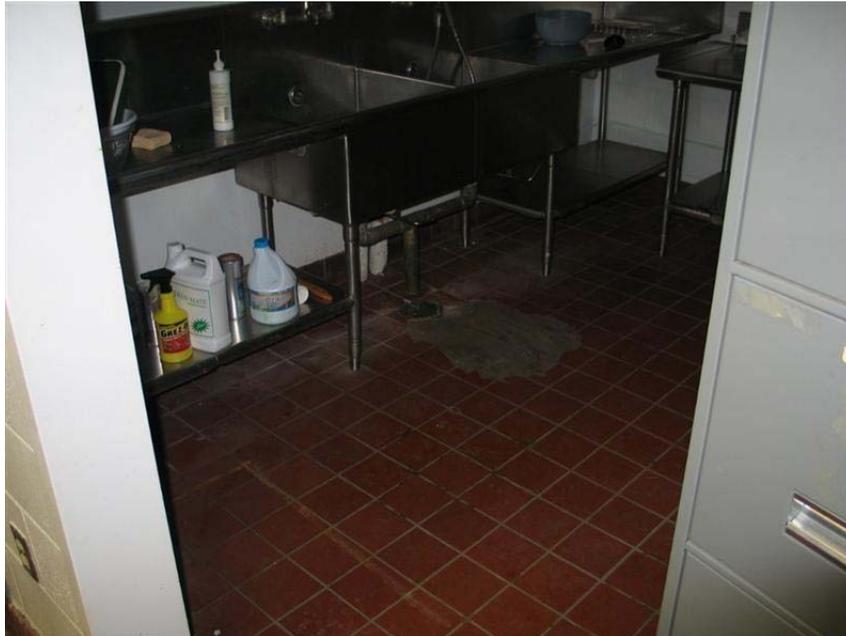
**Photo 25:** View of scullery adjacent to the kitchen of the Training Building. Note cleaning compounds on the shelf to the left and a floor drain in front of the sink.

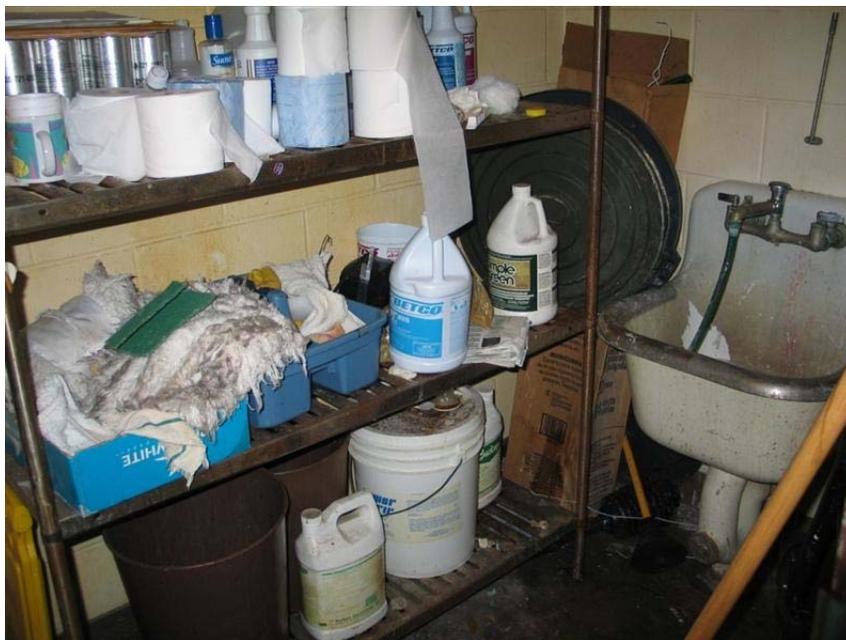
**Photo 26:** A janitor's closet inside the Training Building stores cleaning compounds on a metal shelf.

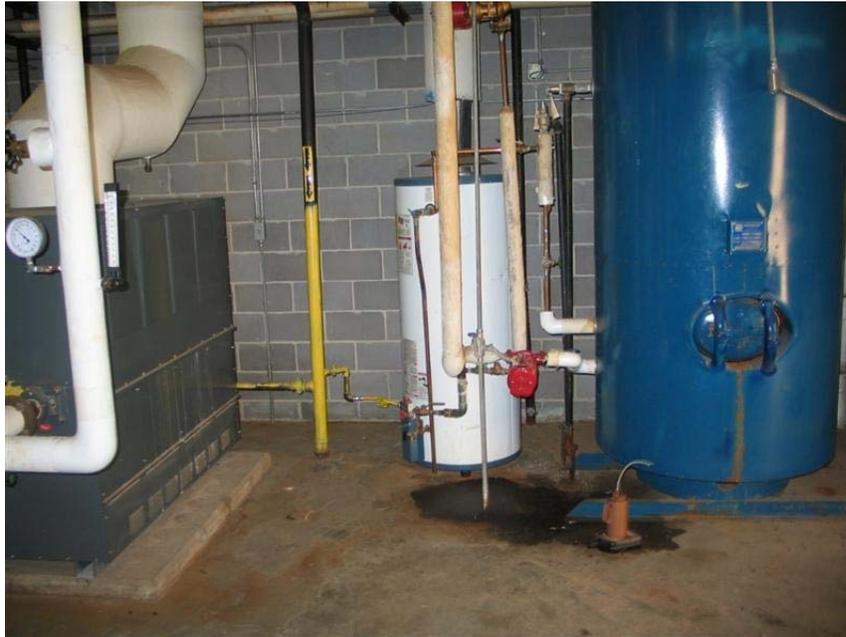
**Photo 27:** Interior of the mechanical room of the Training Building. The 1997 asbestos survey of the Site did not identify ACM in pipe insulation within this room.

Two asbestos inspections have been performed at the Site. According to the *Asbestos Building Reinspection, Bossier City U.S. Army Reserve Center, Bossier City, Louisiana*, November 1997, asbestos-containing material (ACM) was found in roof material, which was scheduled for replacement in the near future, on the Training Building. Floor tile (9-inch) and pipe insulation in the mechanical room of the Training Building were not ACM.

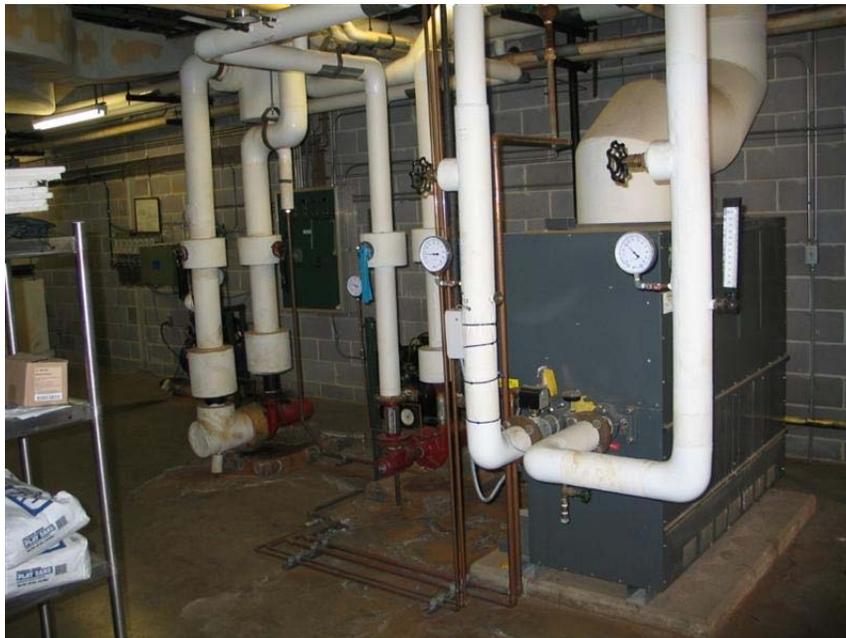
**Photo 28:** Another view of equipment in the mechanical room in the Training Building. A floor drain is visible in the left front and there were other floor drains in this room too.

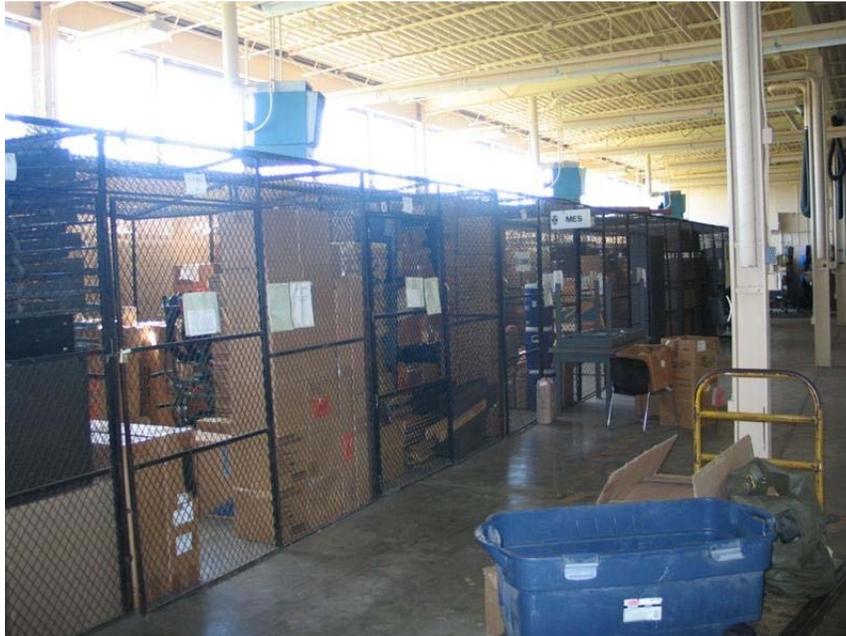
**Photo 29:** Interior view of the OMS, looking southeast toward the east wall. This view shows various equipment storage cages and gas heaters hanging from the ceiling.

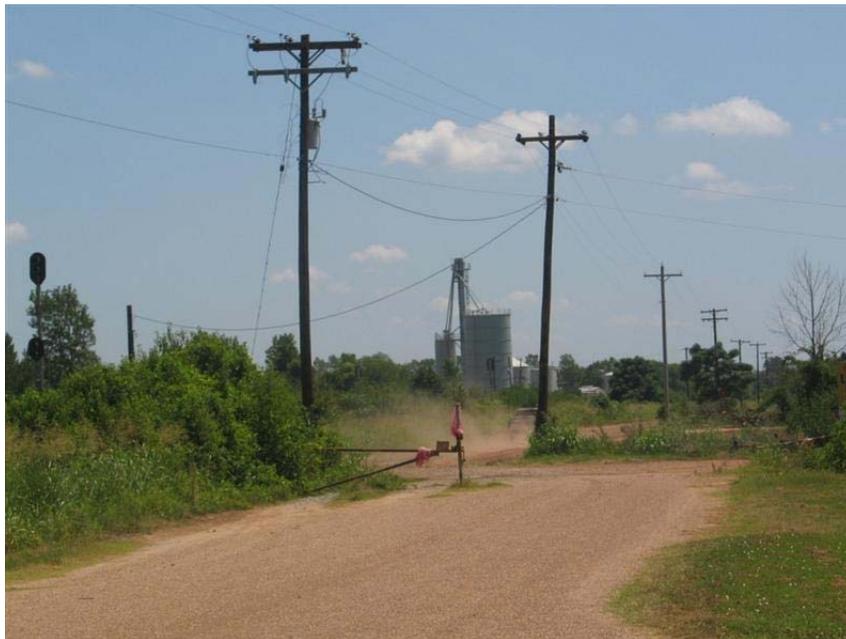
**Photo 34:** Looking east toward the east end of Miller Road, a grain elevator is visible in the background. The power pole in the foreground has a pole-mounted transformer.

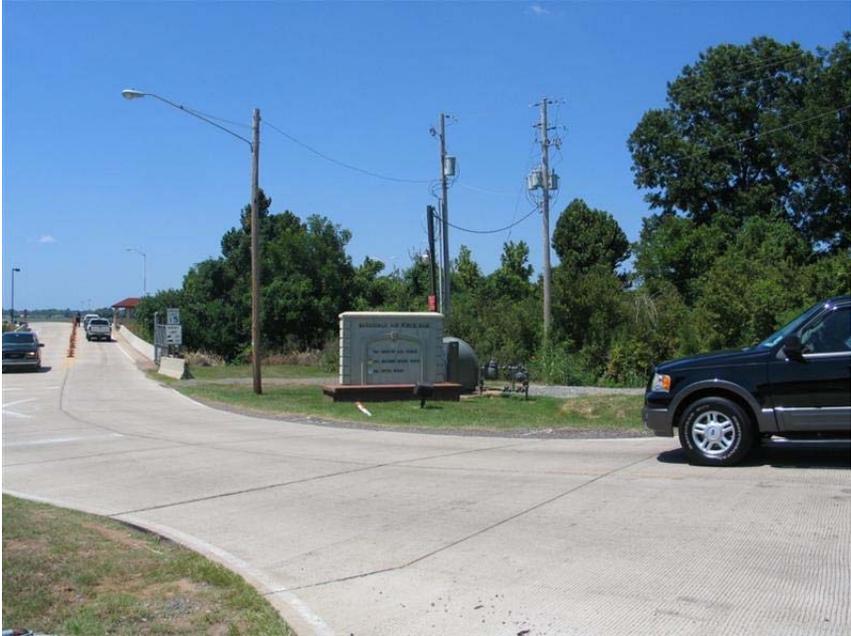
**Photo 35:** Looking to the northwest from the northwest corner of the USAR Center, several power poles with pole-mounted transformers are visible.
