**ENVIRONMENTAL CONDITION OF  
PROPERTY REPORT**

**JULES E. MUCHERT  
U.S. ARMY RESERVE CENTER (TX023)  
10031 EAST NORTHWEST HIGHWAY  
DALLAS, TEXAS 75238**

**March 15, 2007**

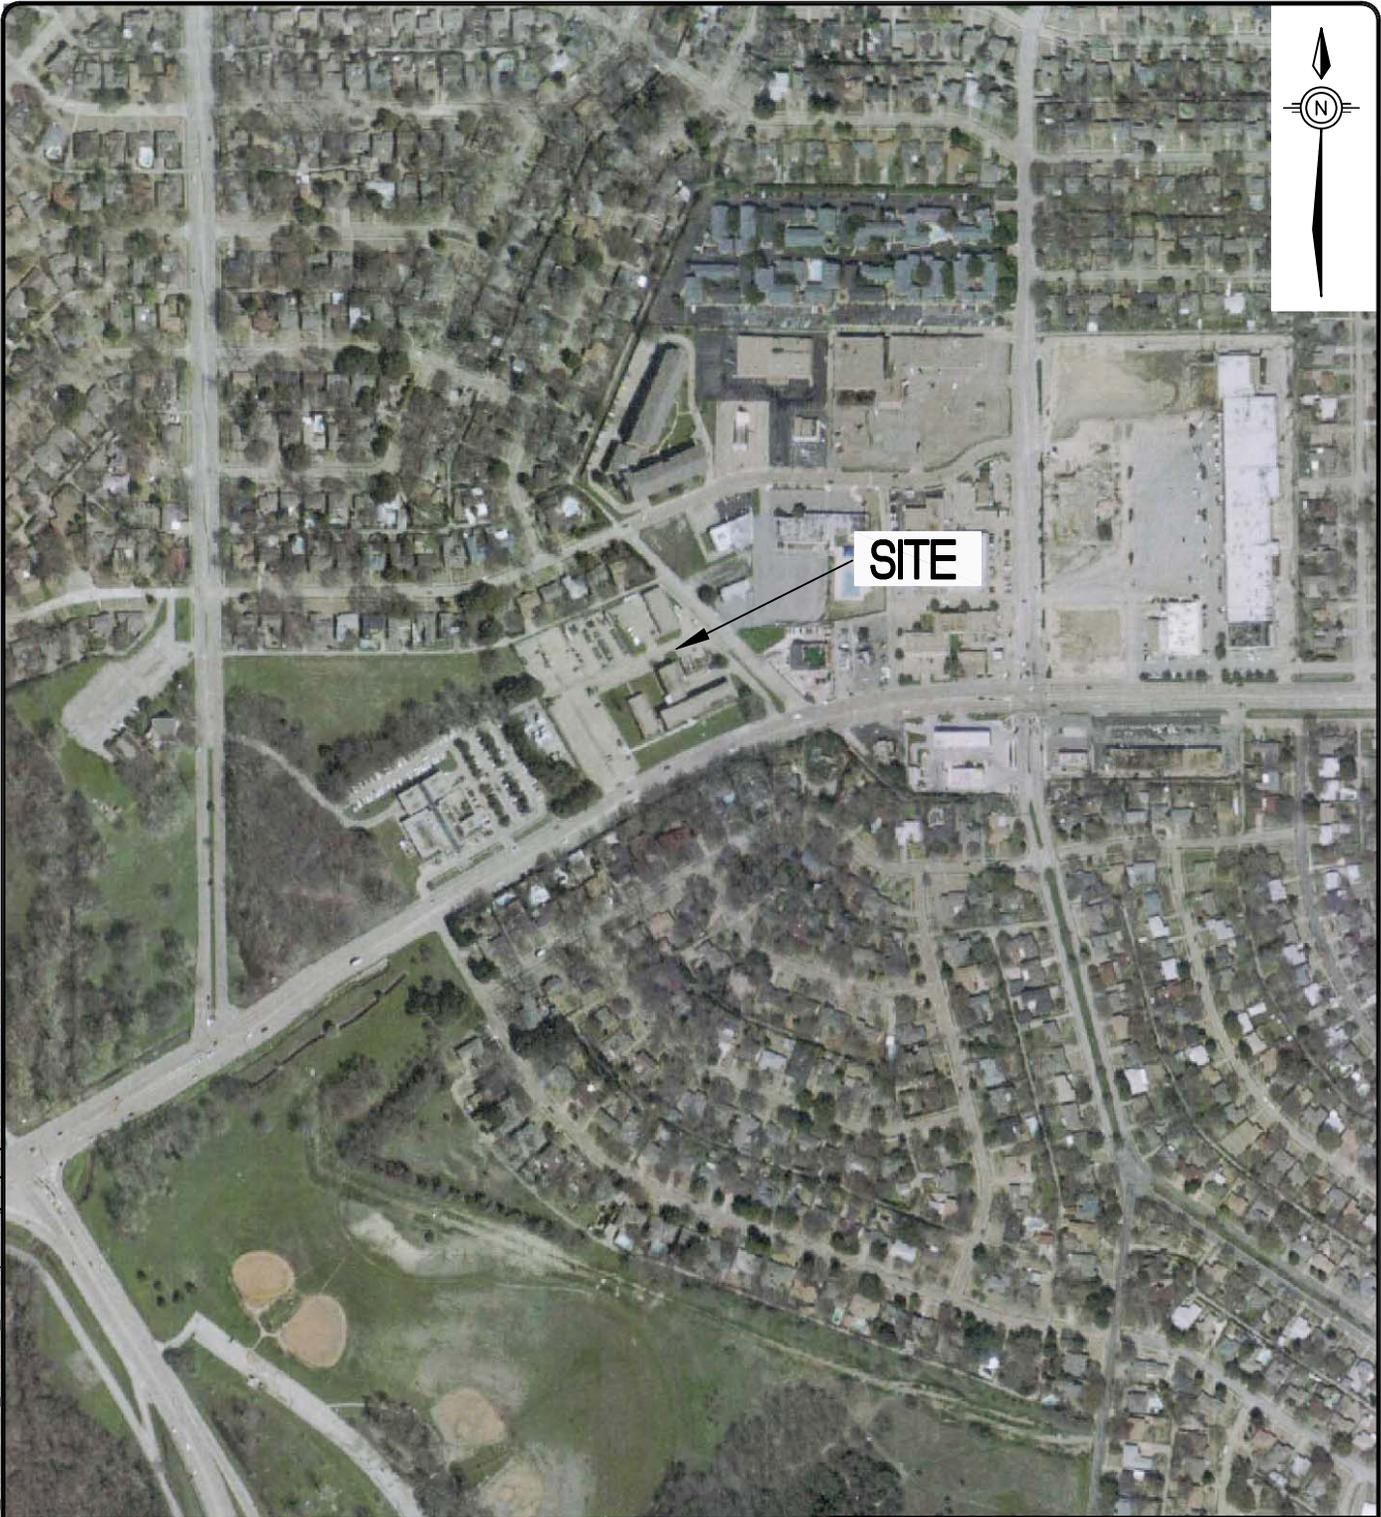
FIGURE 17  
2001 AERIAL PHOTOGRAPH  
ENVIRONMENTAL CONDITION OF PROPERTY  
JULES E. MUCHERT USARC  
DALLAS, TEXAS

- **2001 (Figure 17).** This figure shows the USAR Center and surrounding areas to be essentially the same as during the August 1, 2006 Site reconnaissance.

Figure 17 in Appendix A provides a 2001 aerial view of the Site and adjacent properties. The Site is bounded by East Northwest Highway to the south and Thurgood Lane to the east. The backyards of multiple single-family residences abut the Site on the north (Appendix B, Photograph 18) and there is one apartment complex northeast of the Site (Appendix B, Photograph 19). The northern quarter of the west boundary of the Site abuts White Rock Lake Park (Appendix B, Photograph 20). The remainder of the west boundary is abutted by the TXU Energy Lake Highlands electric power substation (Appendix B, Photograph 21). Single-family residences are located south of the Site, across East Northwest Highway (Appendix B, Photograph 22). A retail shopping center is located east of the Site, across Thurgood Lane. Businesses and other entities noted in the shopping center were Goodyear Tire, Disabled American Veterans, and Knights of Columbus (Appendix B, Photographs 23 and 24). Table 2 provides a list of adjacent properties with their directional location from the Site and zoning.

According to the City of Dallas Web site, the Site is zoned R-7.5(A), Single-Family Residential, with 5,285 housing units within one mile of the Site. The Site is located in a mixed-use area that includes commercial, residential, and open park areas. Figure 17 in Appendix A is a 2001 aerial photograph of the USAR Center and surrounding properties and depicts current land uses.
